# Manhole Inspection Summary

Manhole # S35U\_\_057MH

Insp Date: **2/14/08 10:41 AM**

**Location** Address: **1452 light st**

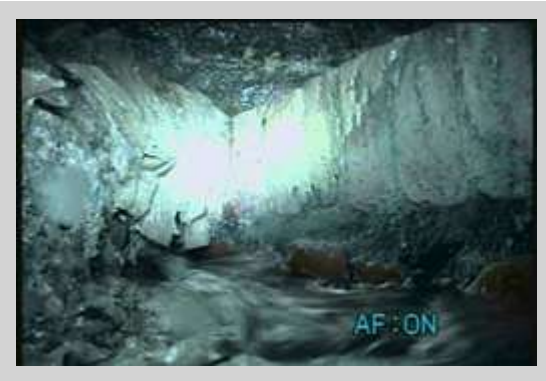
10 in. Circular Gravity Sewer  
Pipe Out @ 12 O'Clock

Pipe Height: 0 (in.) Direct  
Pipe Material: **Clay** ☐ Pipe Lined  
Invert Depth: **11.90** (ft.) Flow Characteristics: **Fast**  
Deposits: ☒ None ☐ Mud ☐ ~~Sludgy~~ ☐ Debris ☐ Grease  
Silt Depth: 0 (in.) Deposits Extent:  
Infiltration: **None** Pipe Seal Cond: **Unknown**

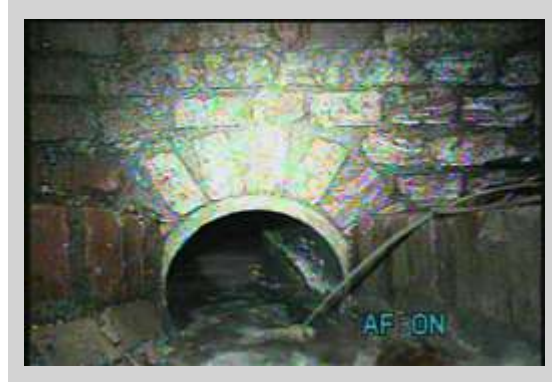
12 O'Clock Outflow  
Pipe Out @ 12 O'Clock (after  
cleaning)

Drop: **None**

Connects To: **Manhole**
